Date: October 23, 2006

Subject: Earthquake Emergency Response Visit at Lapakahi State Historical Park  
Big Island, Hawaii

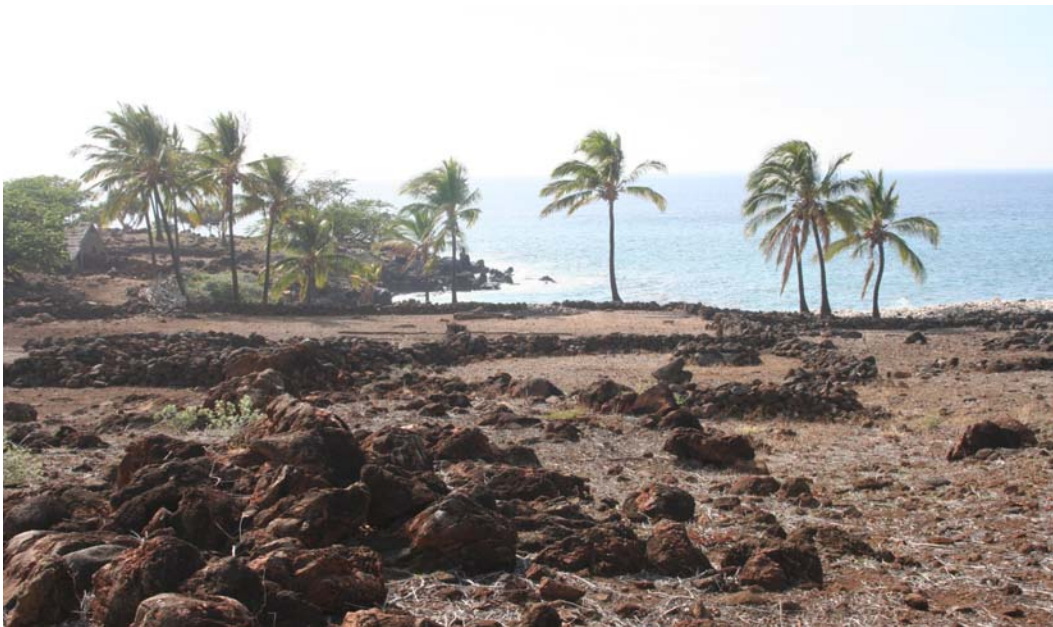
Photo No. 2- Ground view of the historical park.

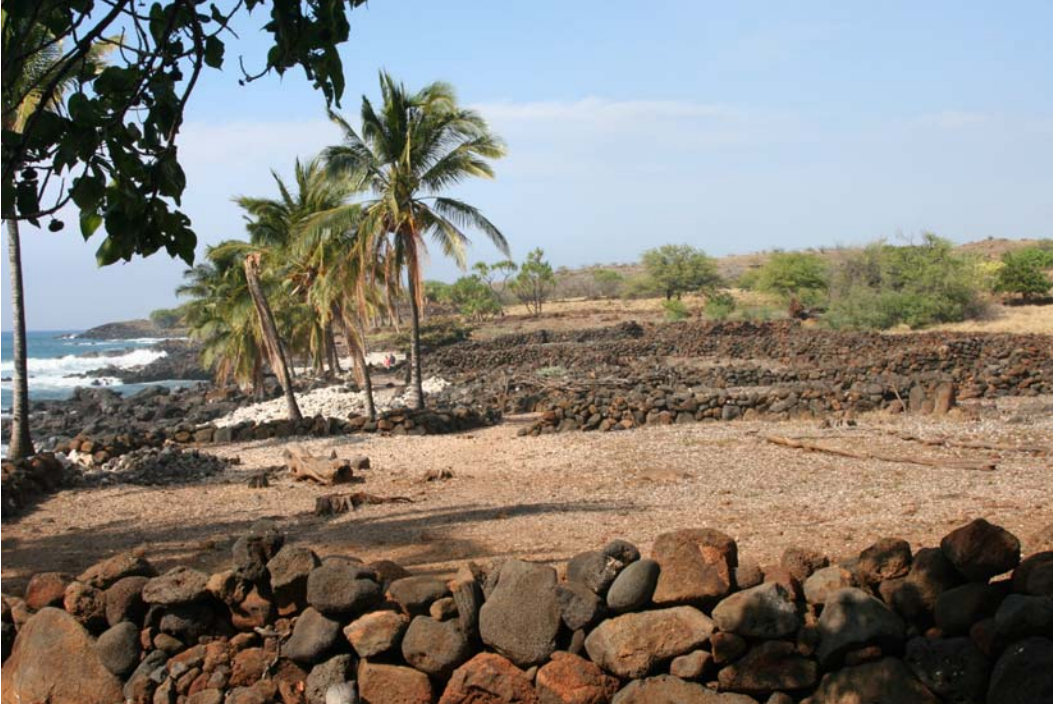
Photo No. 3- Rock walls are the relics of the fishing village.

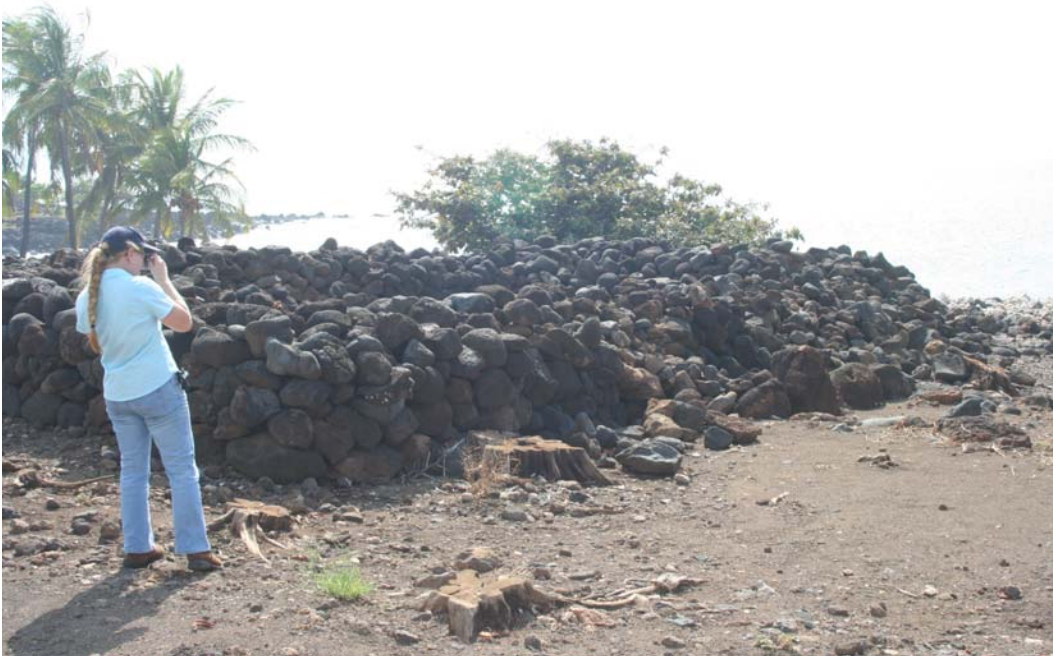
The park is located in a pristine costal area and is the site of a 600 year old Hawaiian fishing village. Rock wall structures are generally the relics of the homes of the villagers. See Photo No. 2 and 3. A walk through the area indicated that in general rock walls have received sporadic damage at various locations within the village. Rocks were separated from the wall and were fallen on the nearby ground. See Photo No. 4 through 7. Also evident was the damage to the walls of the typical village homes. See Photo 8 and 9. The damage seemed consistent throughout the area with rocks being dislodged from the wall structures.

Photo No. 4- Wall failure caused by ground shaking.

The repair of this culturally sensitive structure requires a special type of methodology and approach which is different from conventional construction. It would take a particular master builder carefully chosen from among the Hawaiian community. We anticipate the cost of repair at approximately \$140,000 and a period of construction of 3 months.

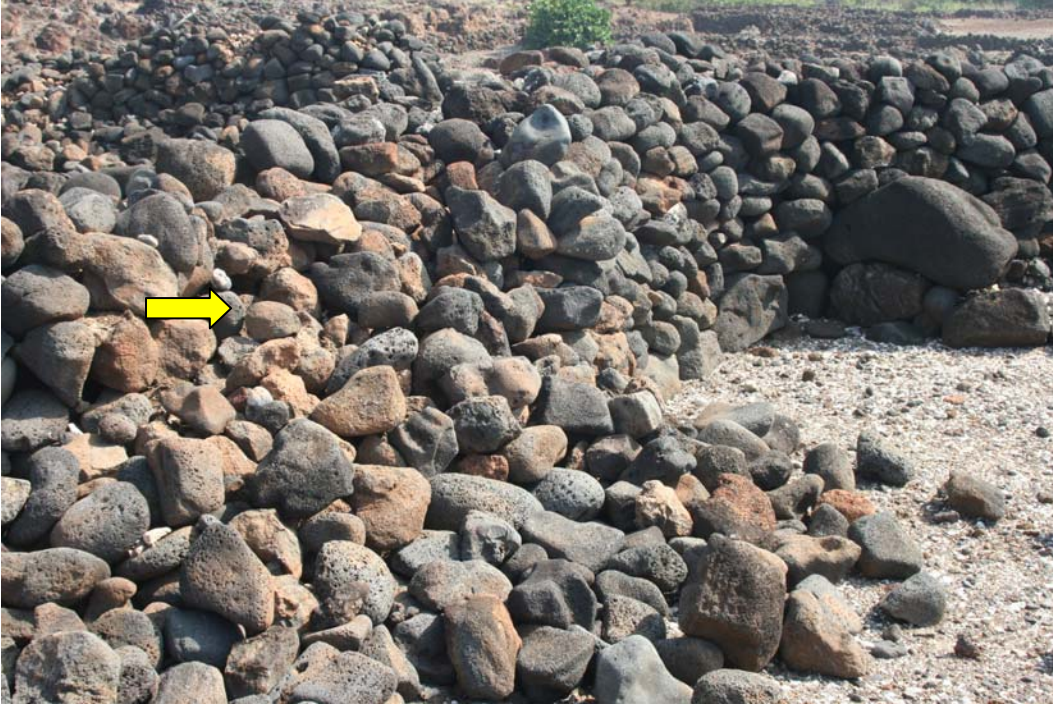
Photo No. 5- Mass failure of rock wall structure.

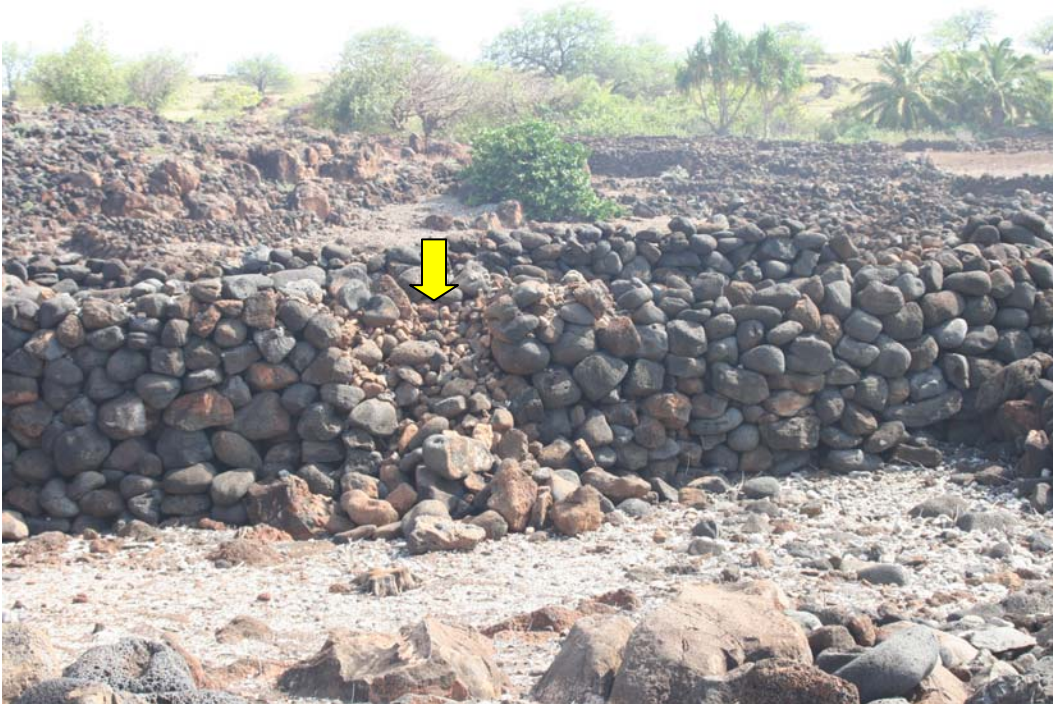
Photo No. 6- Rock wall failure due to earthquake.

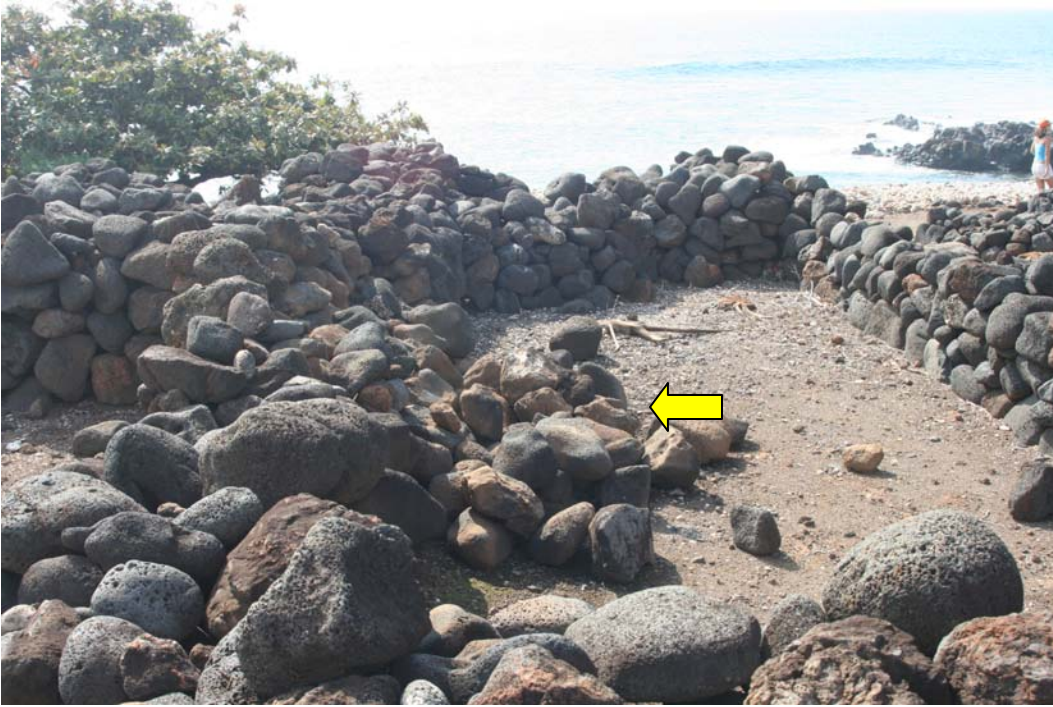
Photo No. 7- Fallen rocks caused by shaking of the ground.

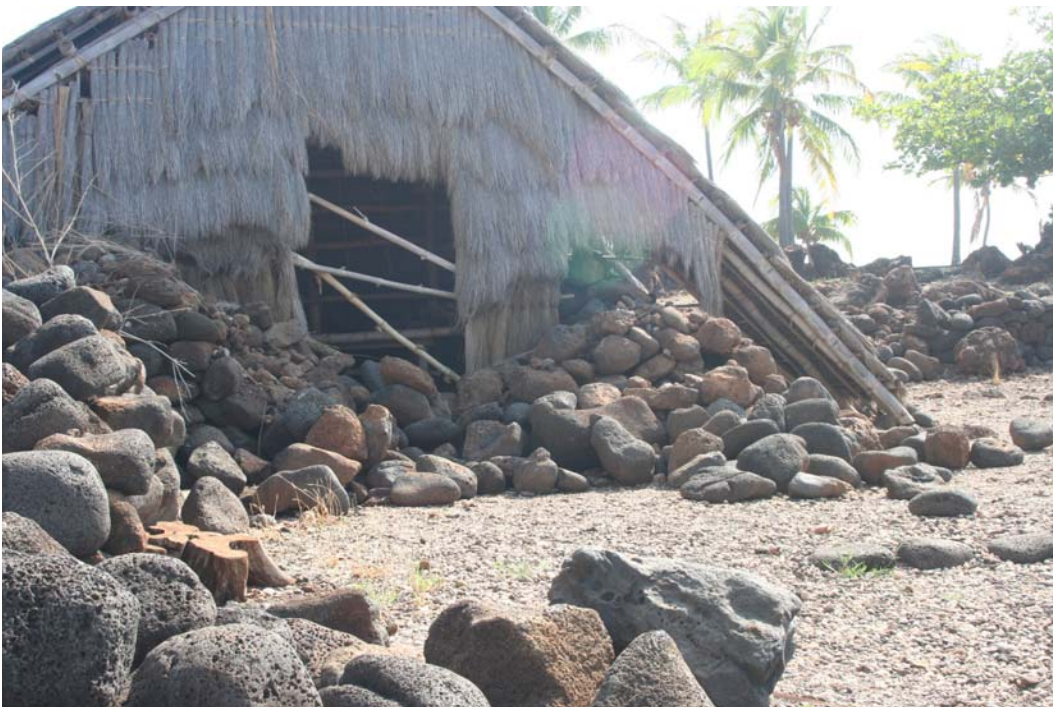
Photo No. 8- Crumbled building walls caused by ground motion.

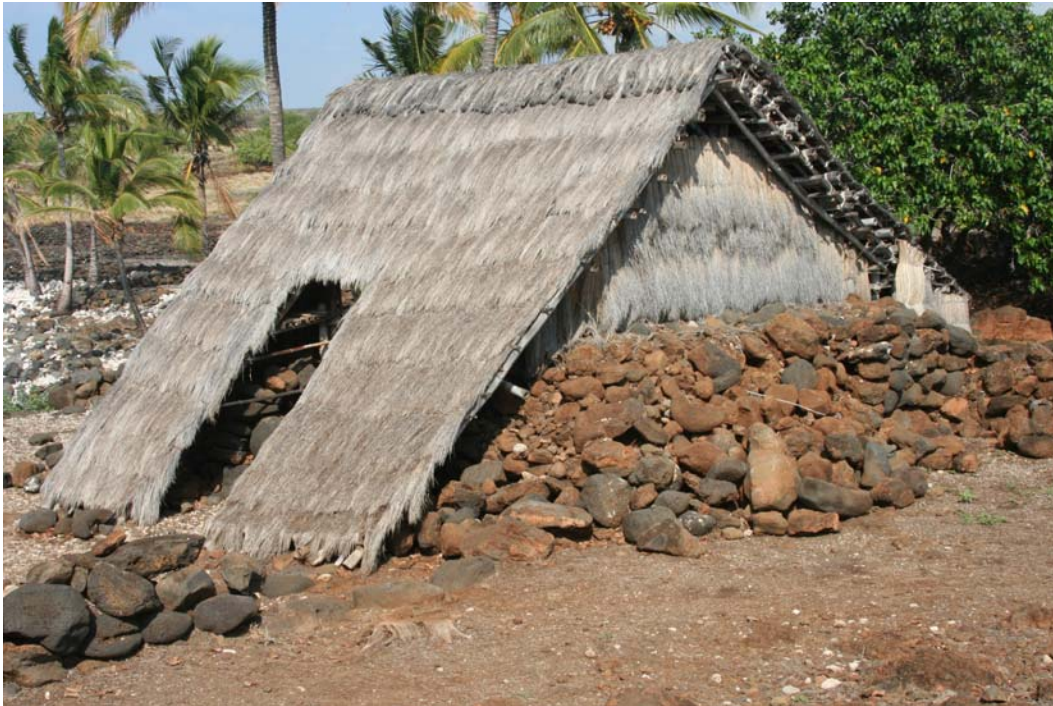
Photo No 9- Wall failure along side of the building.
